Inspection Report # 33

Date: February 22, 2018

Site Address: 4700 Keele Street, Farquharson Building

Project Name: Farquharson Renovation

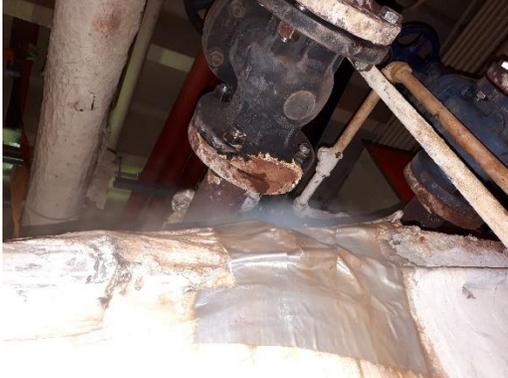
3.4

3.2	One 3 chamber waste decontamination facility has been properly constructed with weighted flaps separating all 3 chambers.
3.3	A leaking steam valve is present near the asbestos-containing insulation that is to be removed. This should be repaired prior to the start of work to ensure workers removing asbestos are not burned by the steam.

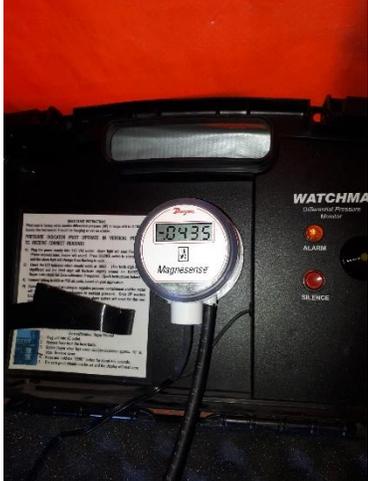
4.0	One negative air unit is providing good negative pressure of -0.043 inches of water. A second unit has been installed and will be used if necessary. Both units are being vented into exhaust ducts within the mechanical room.
